New York State Department of Transportation

Yellow Flag NB2222W005

BIN: 1065318
Feature Carried: 278I278IX2M23027
Feature Crossed: 6TH AVENUE
Orientation: 8 - NORTHWEST
Region: 11 - NEW YORK CITY
County: KINGS
Political Unit: City of NEW YORK
Approximate Year Built: 1962
Posted Load Matches Inventory : Yes
Bridge Load Posting (Tons) : Not Posted for Load
Primary Owner: New York State Department of Transportation
Primary Maintenance Responsibility: 12 - State - Subcontracted to another Party
Typical or Main Span Type: 3 - Steel, 02 - Stringer/Multi-Beam or Girder
This Bridge is not a Ramp
Number of Spans: 322

Location: Span 247, Girder G16 at Pier 247

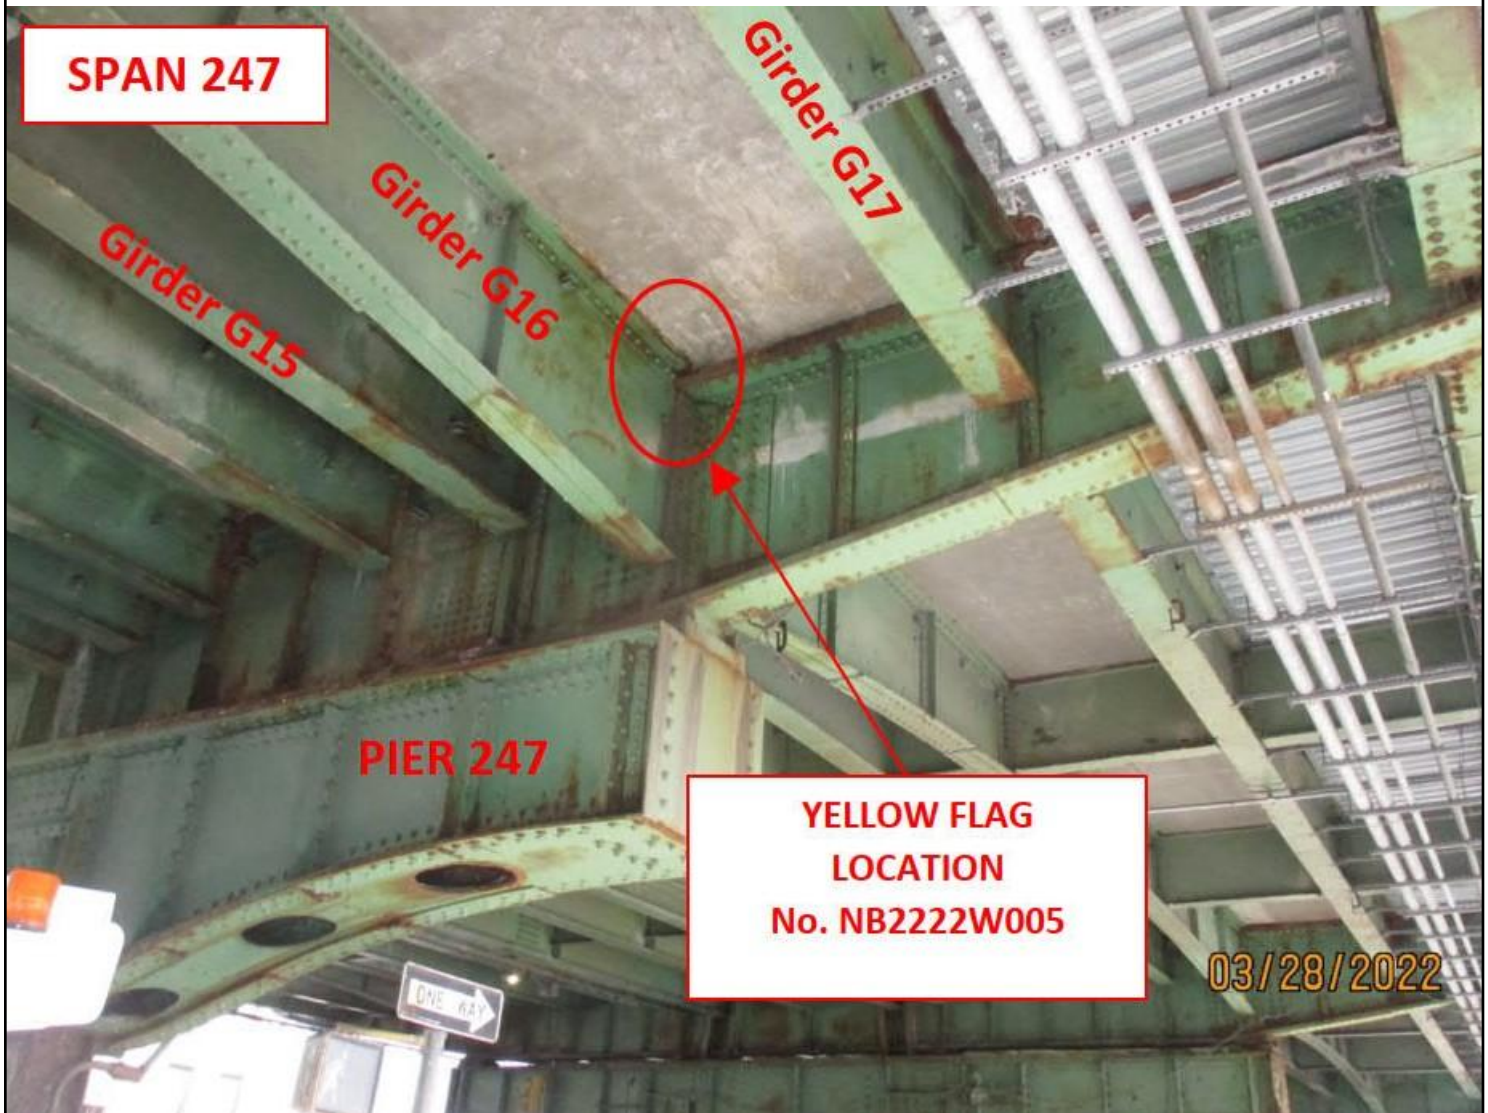
Photo Number: 1

Attachment Description: Span 247, Girder G16 at Pier 247. General view of flagged location. Looking end left.

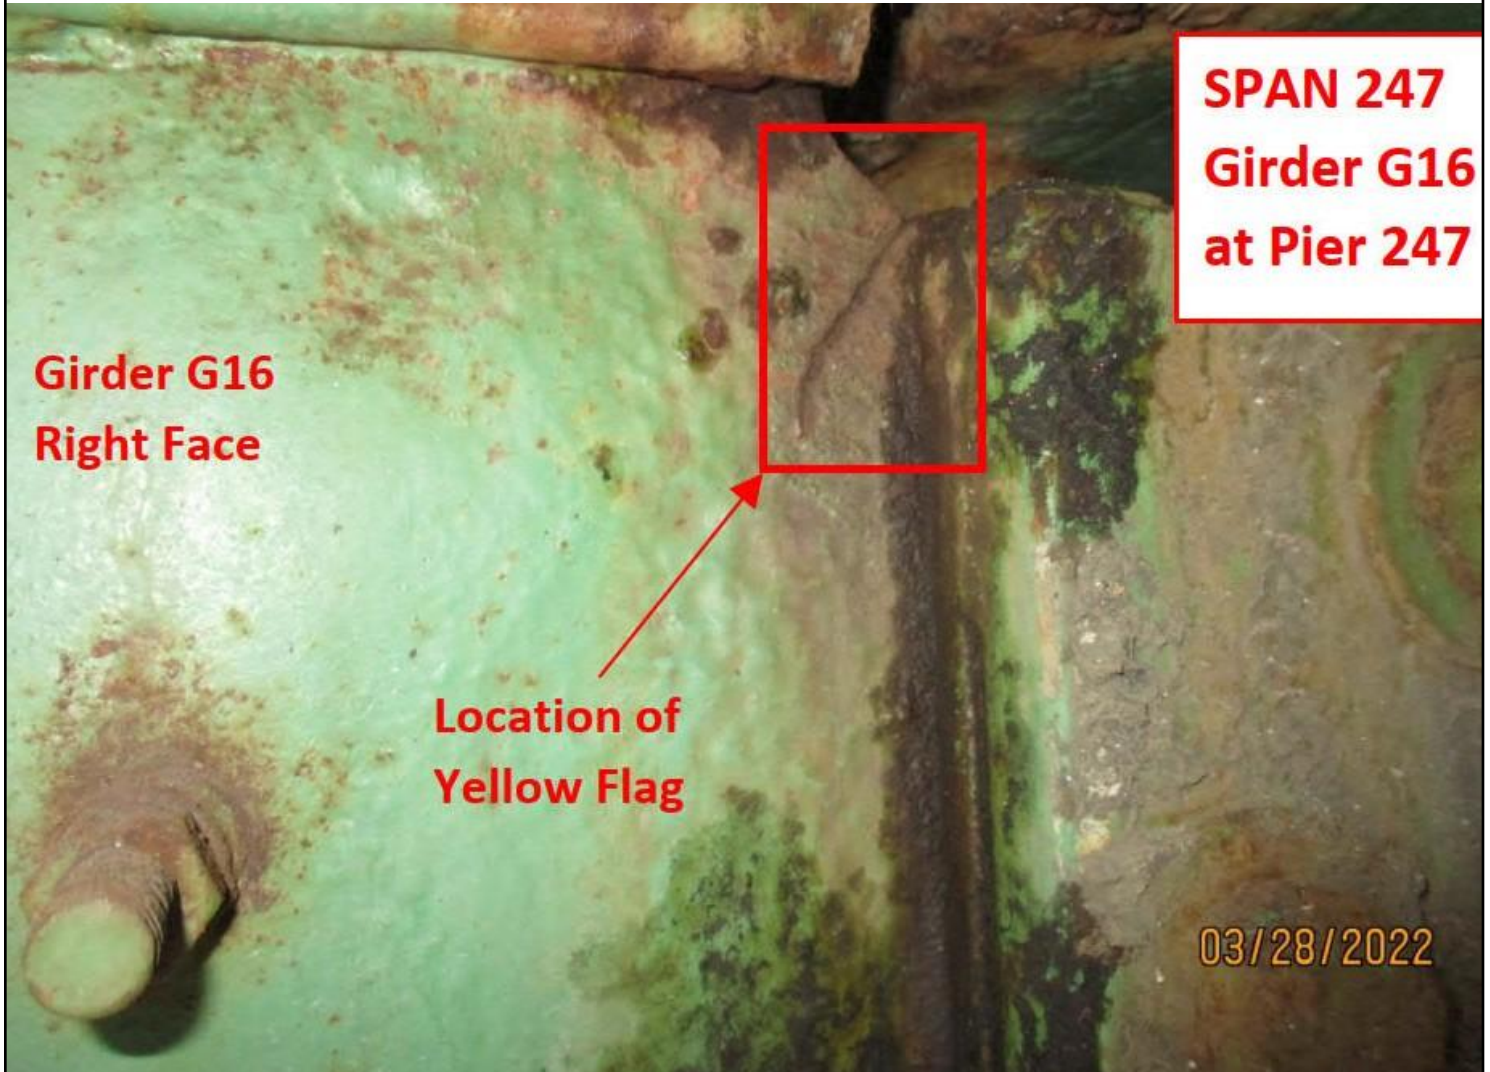
Photo Number: 2

Description: The web of the Girder at the upper cope has a 1.5" long diagonal crack (no change from the previous inspection) (Photos 2 and 3). A Dye Penetration test was performed on the crack to determine the extent of the crack.

Attachment Description: Span 247, Girder G16 at Pier 247. Close-up view of flagged location. Looking left.

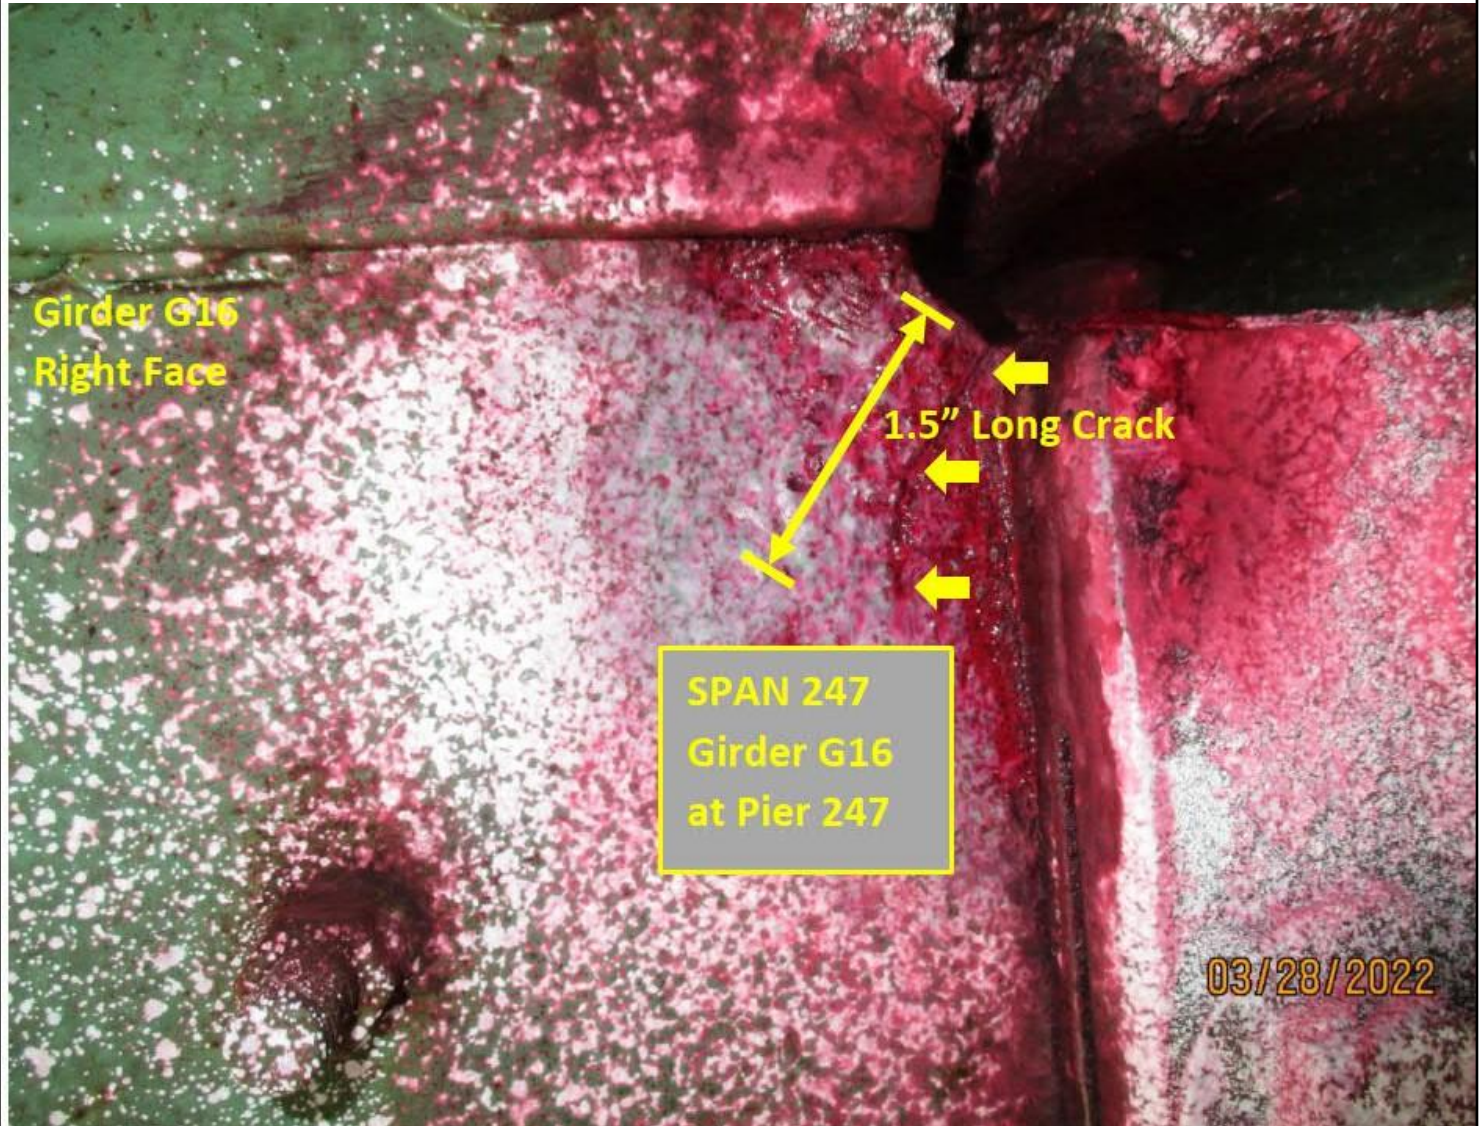
Photo Number: 3

Attachment Description: Span 247, Girder G16 at Pier 247. Close-up view of 1.5" long diagonal crack at the upper cope. Looking Left.

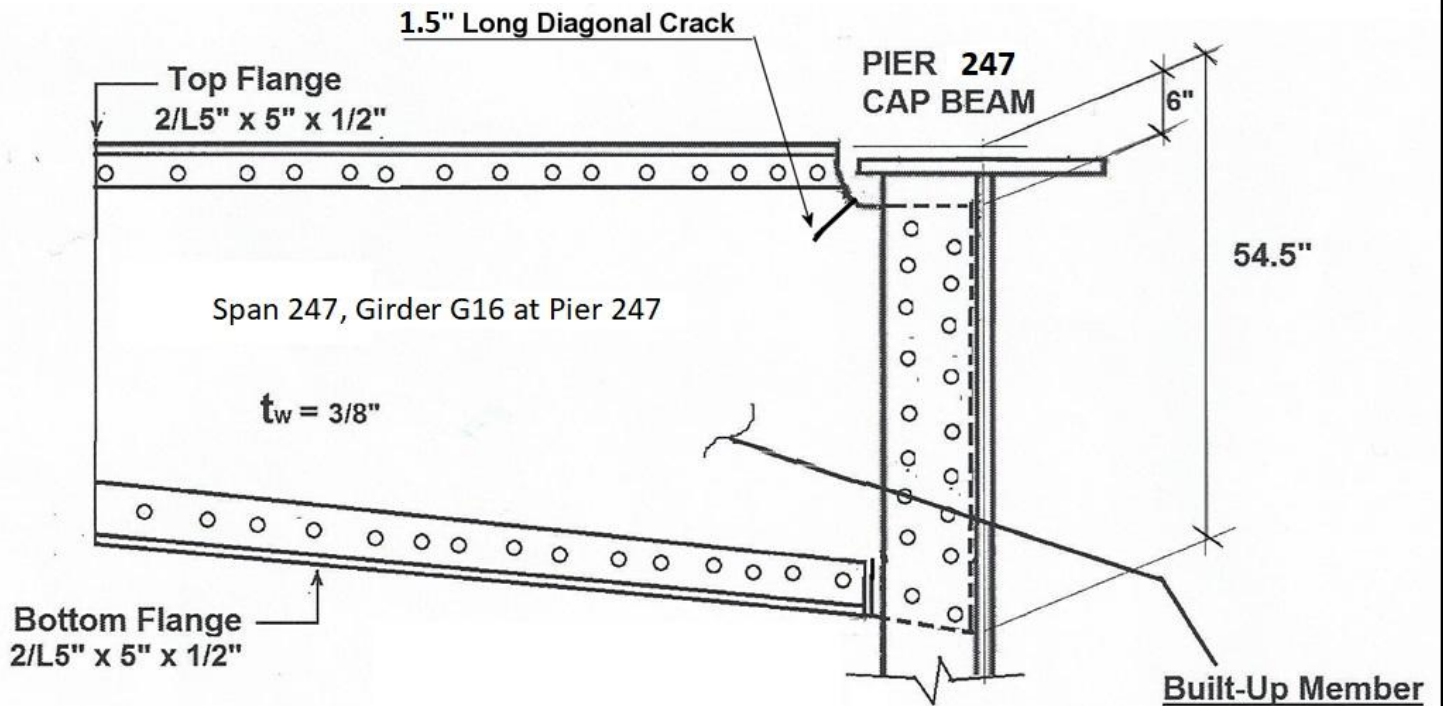
Photo Number: 4

Vary depth web: 54.5" b-to-b Ls @ Piers 246 and 247 and 33" @ midspan

Web thickness = 3/8"

Bottom and Top Flanges are two equal leg angles L 5" x 5" x 1/2"

Attachment Description: Span 246 G16 at Pier 247 Sketch

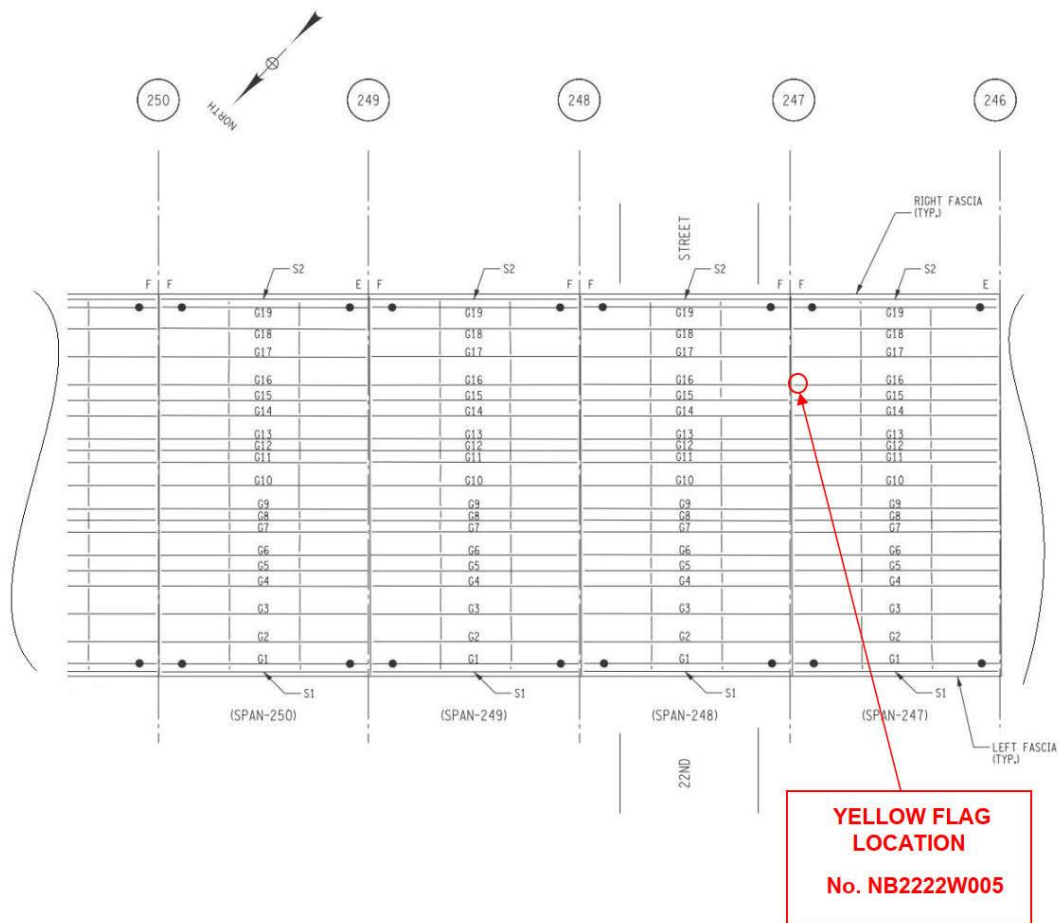
Photo Number: 5

The affected member of Girder G16 is a load path redundant built-up steel girder consisting of varying web depths of 3/8" thick and two equal leg angles (L 5" x 5" x 1/2") for the top and bottom flanges. The spacing between Girder G15 and G16 is 3'-9.75" on center and 6'-11" on center from G17.

Attachment Description: Span 247 G16 at Pier 247 Framing Plan
